Report Title: CAA Inspection Report for Wissmach Glass
Inspection Date(s): 09/25/2019
Regulatory Program(s): N/A

Company name: Paul Wissmach Glass
Facility Name: Wissmach Glass
Facility Location: 420 Stephen Street
Paden City, WV 26159
Mailing Address: 420 Stephen Street
Paden City, WV 26159
County/Parish: Tyler/Wetzel
Facility Contact: Dan Lynch
(304) 337-2253
AFS Number: WV00009500004
Permit Number: N/A
NAICS: 327212
SIC: 3229

Attachment 1: Photograph Log Wissmach Glass

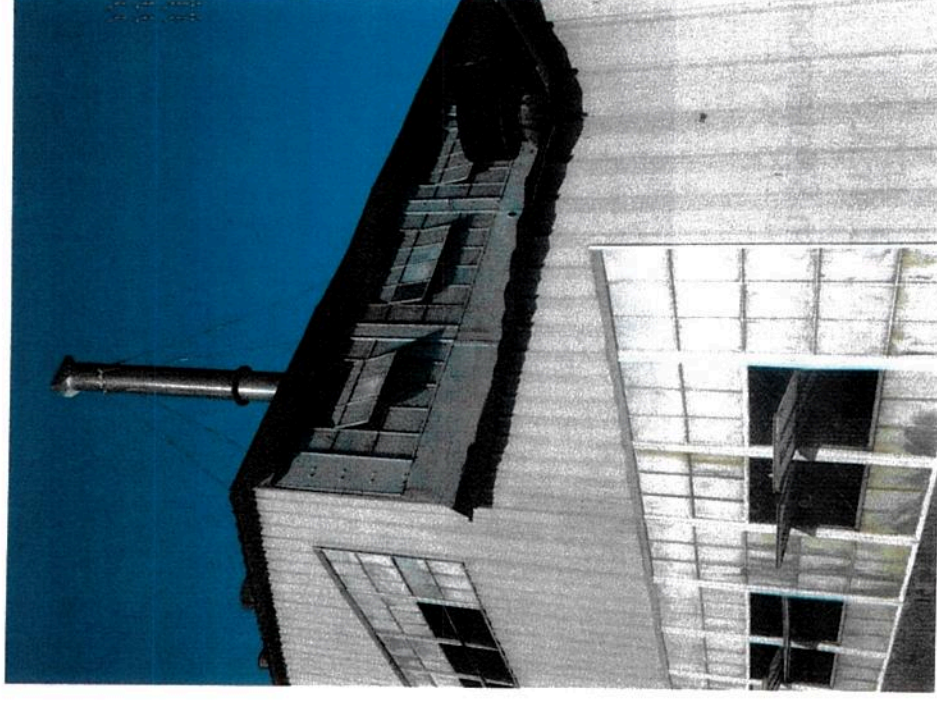
RIMG0133.JPG taken by Christopher Williams on September 25, 2019 at 9:10 AM

Wissmach explained that two large metal stacks vent emissions from most of the furnaces. Furnaces #2, #3, #4, #7, and #8 vent to the eastern most stack. Furnaces #10, #11, #12, #13, and #14 vent to the stack closer to the river. Furnace #1 has separate stack located on the roof and Furnaces #5 and #6 vent to common stack on the roof of the building. Furnaces #1, #5 and #6 are all day tanks.

Picture of stack for furnace #5 and #6

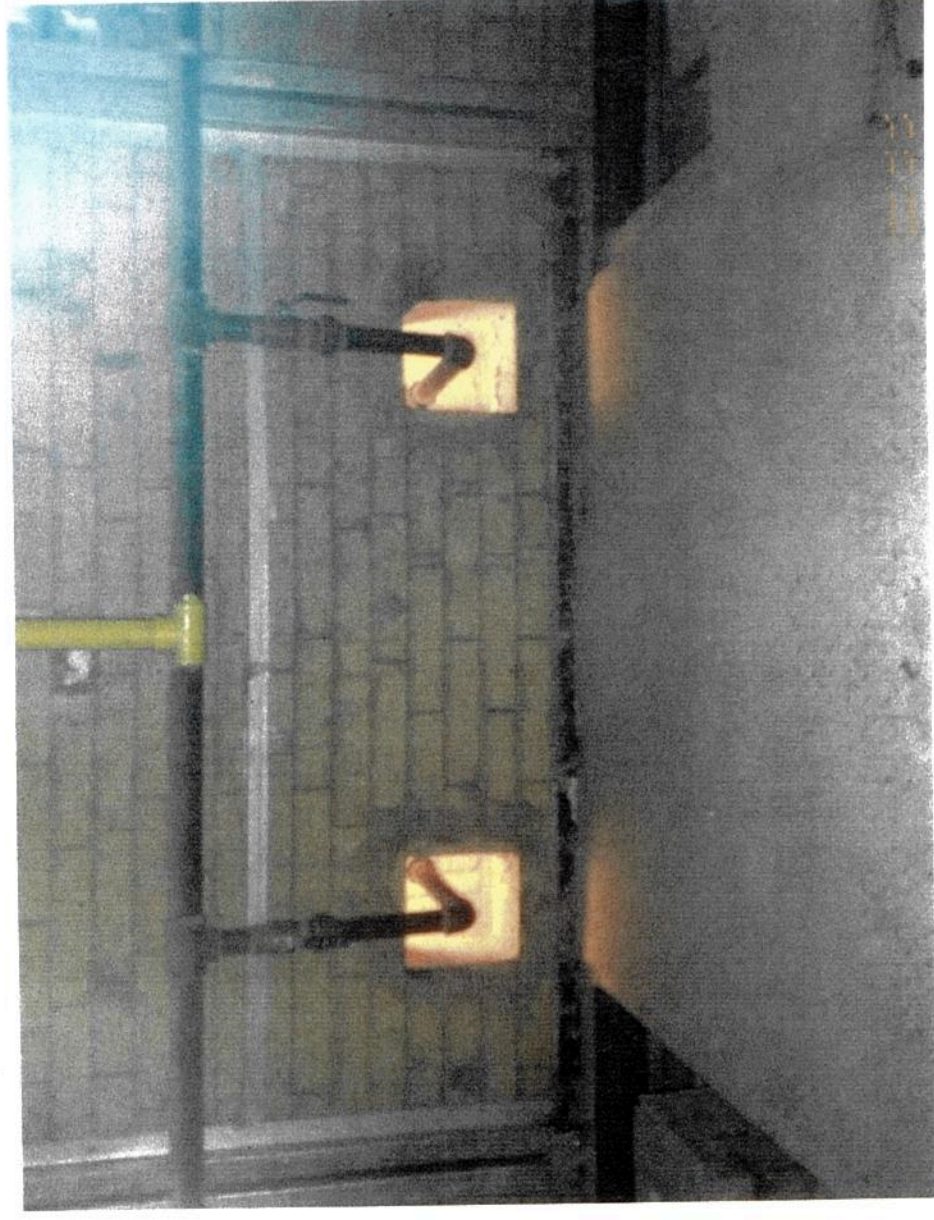
IMG0136.JPG taken by Christopher Williams on September 25, 2019 at 10:39 AM

Picture of the back of furnace #10 depicting the burner system of a pot furnace

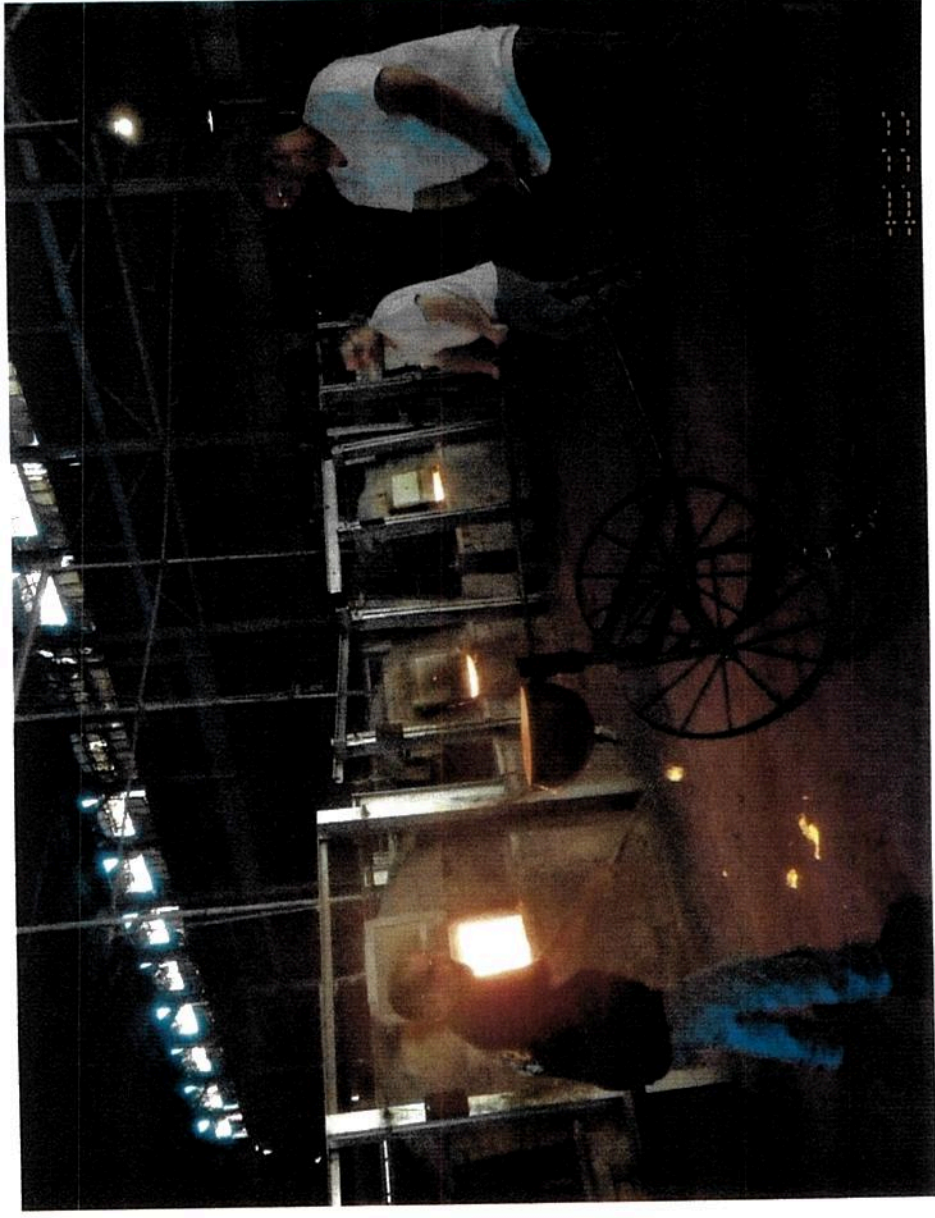
RIMG0138.JPG taken by Christopher Williams on September 25, 2019 at 10:41 AM

Picture of the ladle or crucible used to extract molten glass from the furnace

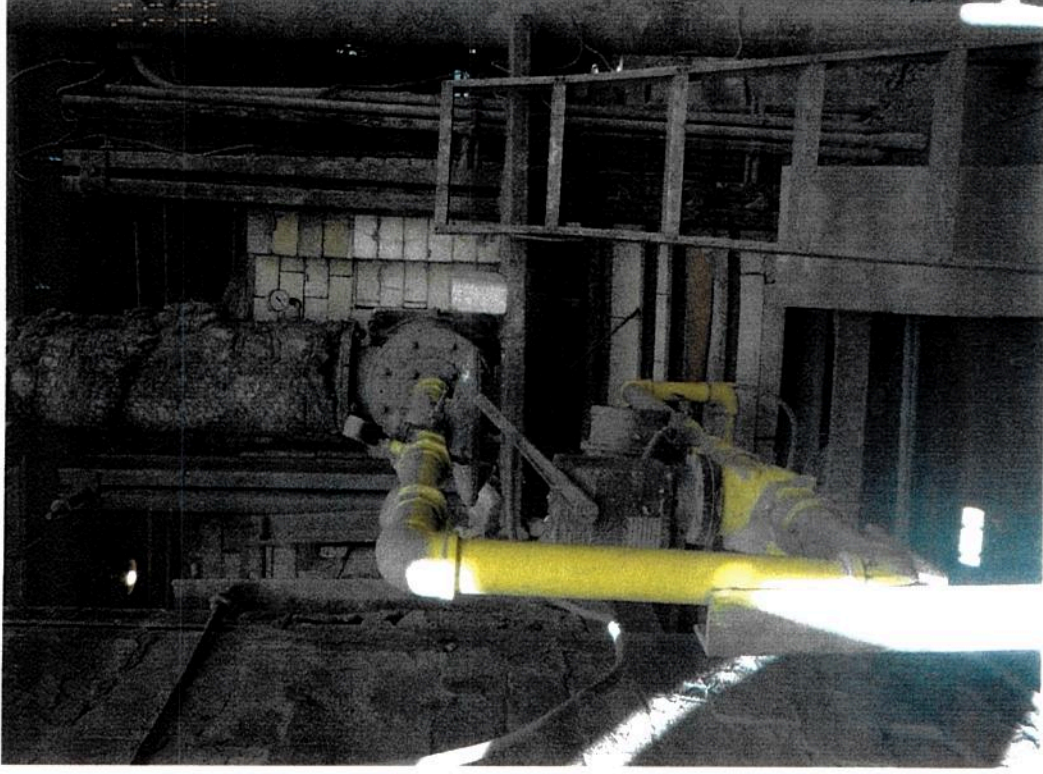
RIMG0143.JPG taken by Christopher Williams on September 25, 2019 at 10:53 AM

Picture of the left side of furnace #5 depicting the burner system of a day tank furnace

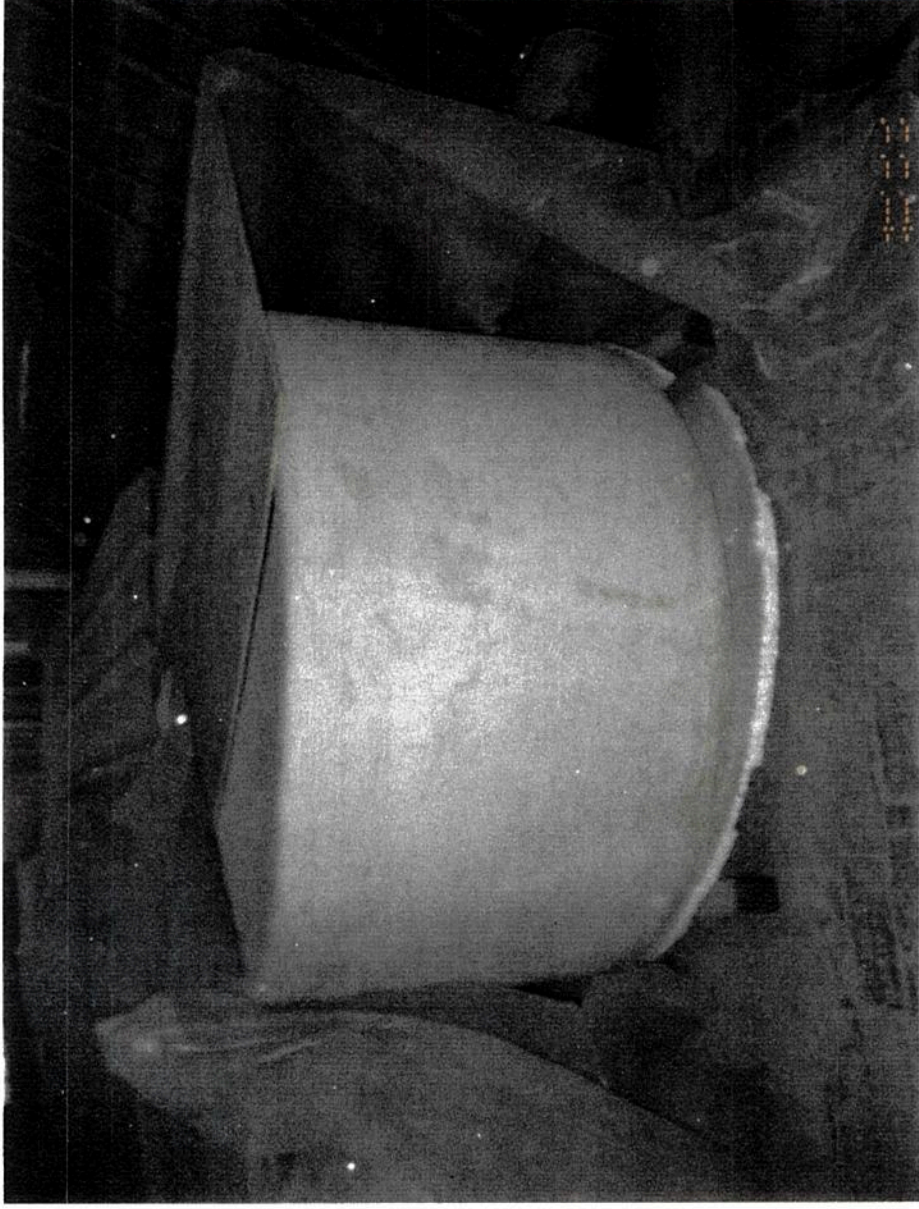
RIMG0144.JPG taken by Christopher Williams on September 25, 2019 at 11:09 AM

Wissmach uses clay pots that are three different sizes: small, medium, and large. A small pot can hold two batches while a large pot can hold six batches. All finished products are shipped via truck from the facility.

Picture of a large pot

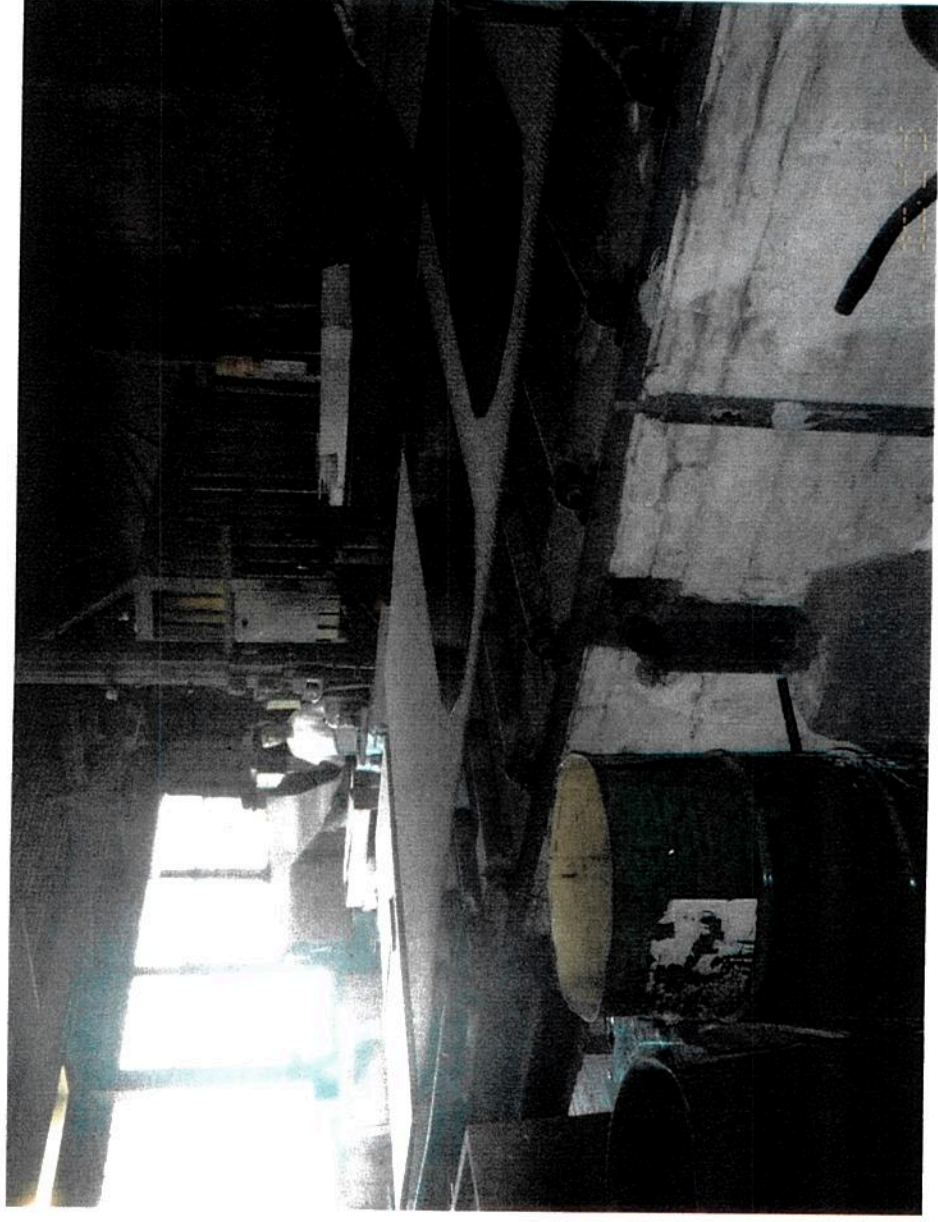
Picture of cooled flattened glass exiting the lehr
RIMG0145.JPG taken by Christopher Williams on September 25, 2019 at 11:24 AM
